ミネソタの橋梁崩壊

2008年6月27日 井上 雄城

2. Plates focus of Minn. bridge collapse probe

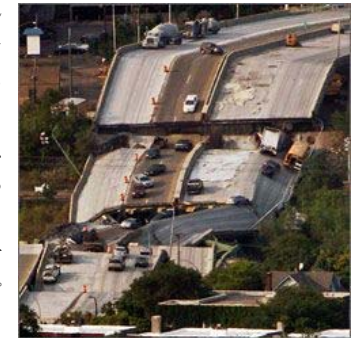
写真-1 崩壊した橋梁

ミネアポリスの北部からの主要通勤ルートの一つであるこの橋梁は、昨年8月1日夕方のラッシュアワーに115フィート（約35m）下のミンシッピー川に崩落した。死者13名に加え、およそ100名の負傷者が出た。

捜査当局によると、調査官がI-35Wの橋梁の残骸に破砕されたガセットプレート16枚を発見したと述べた。8枚のプレートは、崩落が始まった橋梁の南側にあったことを明らかにしている。

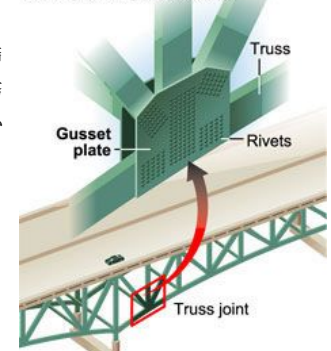
図-2 ガセットプレート

ガセットプレートは、橋梁の重量を支える鋼桁をボルトで固定するのに使用される鋼板である。プレート1枚に不具合があっても橋梁全体が崩落してしまうため、桁よりもはるかに強度を持たせた設計とするのが一般的である。

破砕が確認されたことから、技師らが橋梁の接合に使用されたプレートの適性を計算したところ、厚さ0.5インチのプレートは本来であれば、その2倍の1インチの厚みが必要であったことが判明した。（※1インチは約25mm）

調査ではまた、ガセットプレートは、強度に余裕があると想定されているため、橋梁に重量が追加される際に分析が行われても、ガセットの設計は通常検討の対象にはされないことも明らかとなった。NTSBが崩落の原因を言明するまでには何カ月にもわたる調査が行われるが、現在調査ではガセットプレートに焦点が当てられている。

Federal investigators have concluded that overburdened steel support plates — gusset plates — led to the collapse of the Interstate 35W bridge in Minneapolis. Design changes that increased the weight of the bridge in 1977 and 1998 may have led to fractures in as many as 16 gusset plates.

米国運輸安全委員会(NTSB)は1月15日、各道路局に対し、鋼桁橋への荷重を追加する場合には常にガセットプレートの安全性評価を実施するよう要請を出すとのこと。
